MEASUREMENT OF POLYETHYLENE PIPE PARAMETERS DURING AN
OCEAN DEPLOYMENT

Final Report

FINAL REPORT

MEASUREMENT OF POLYETHYLENE PIPE PARAMETERS

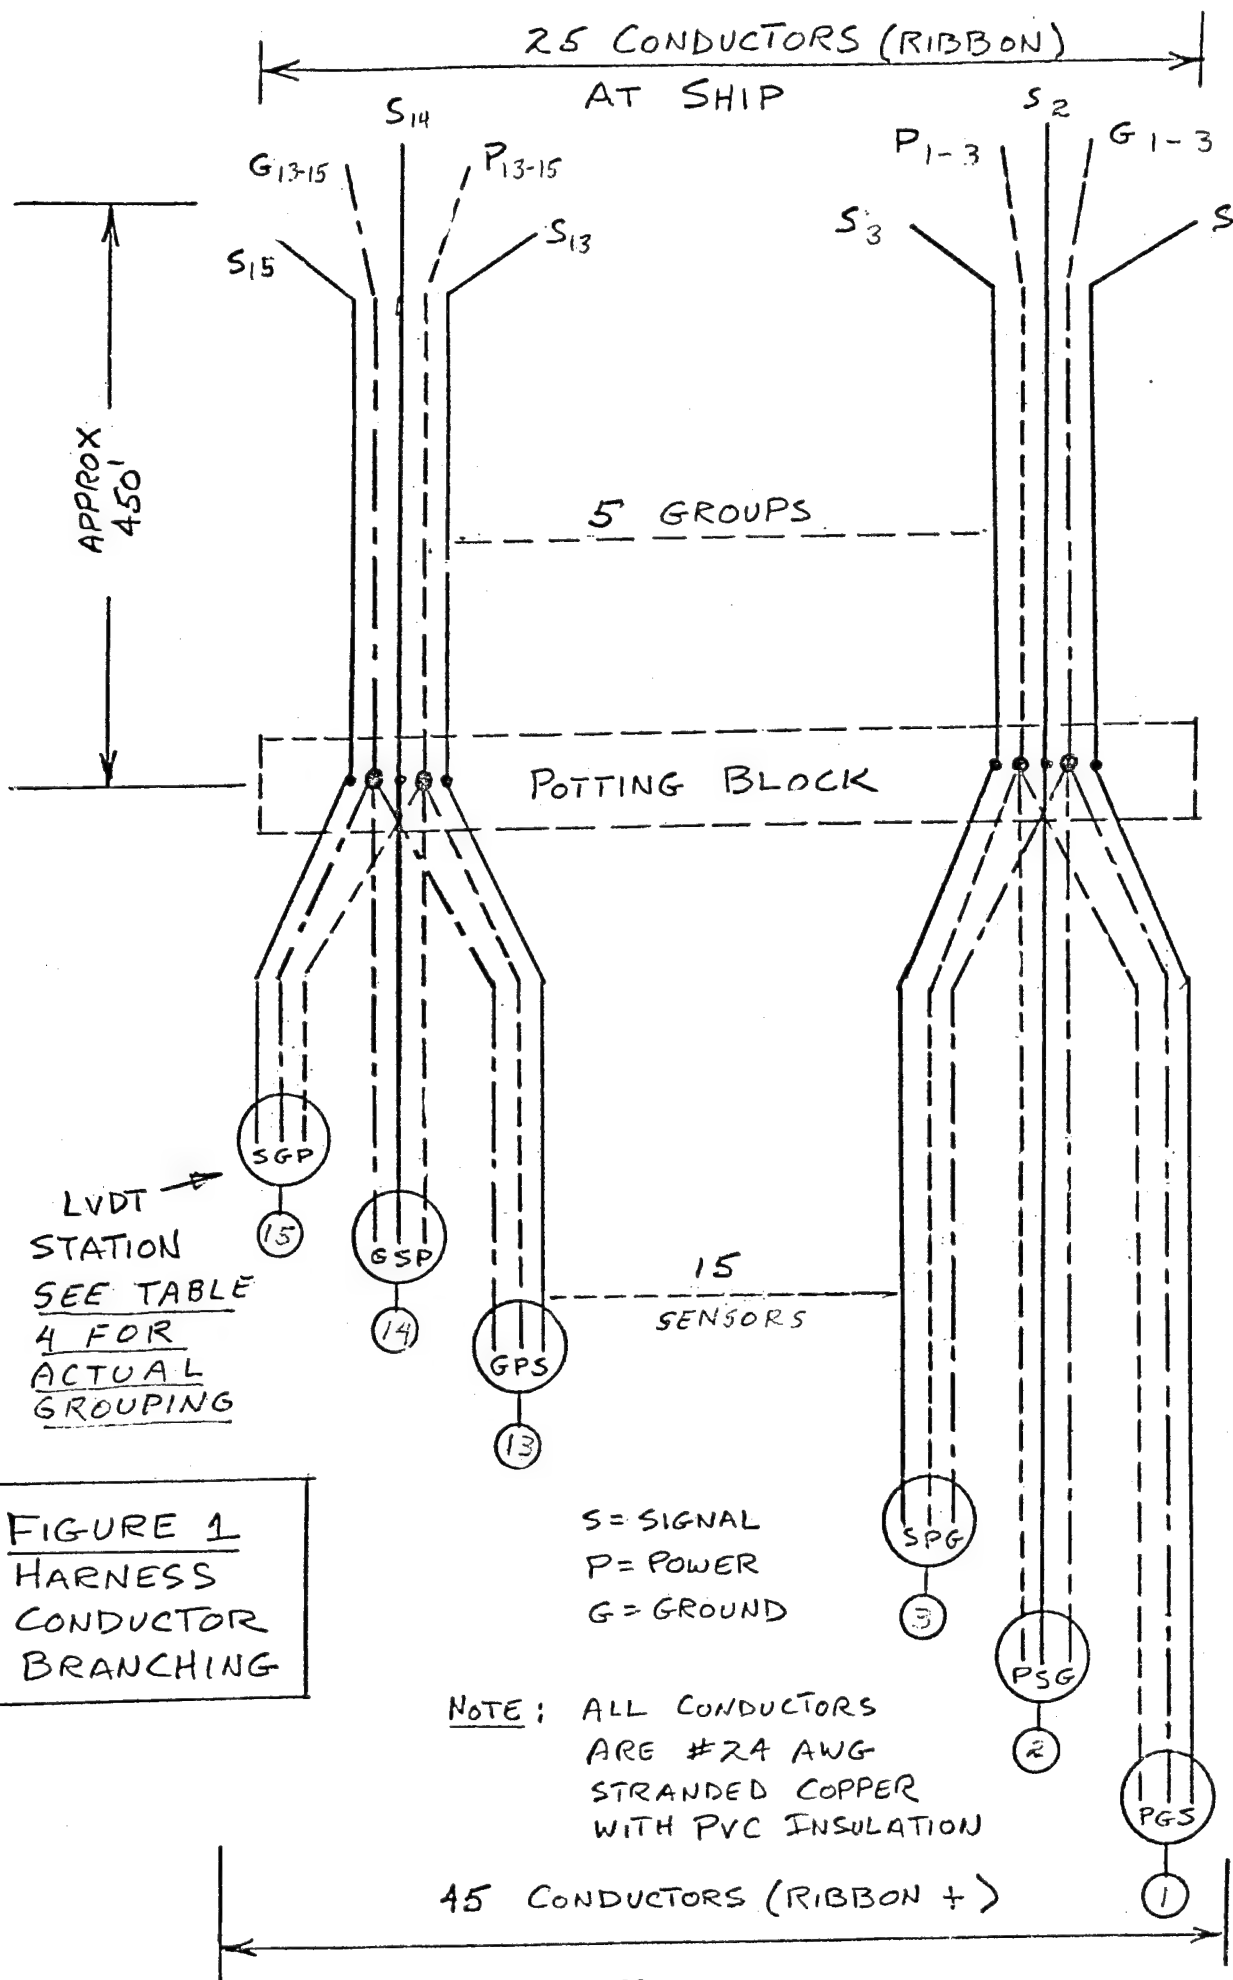
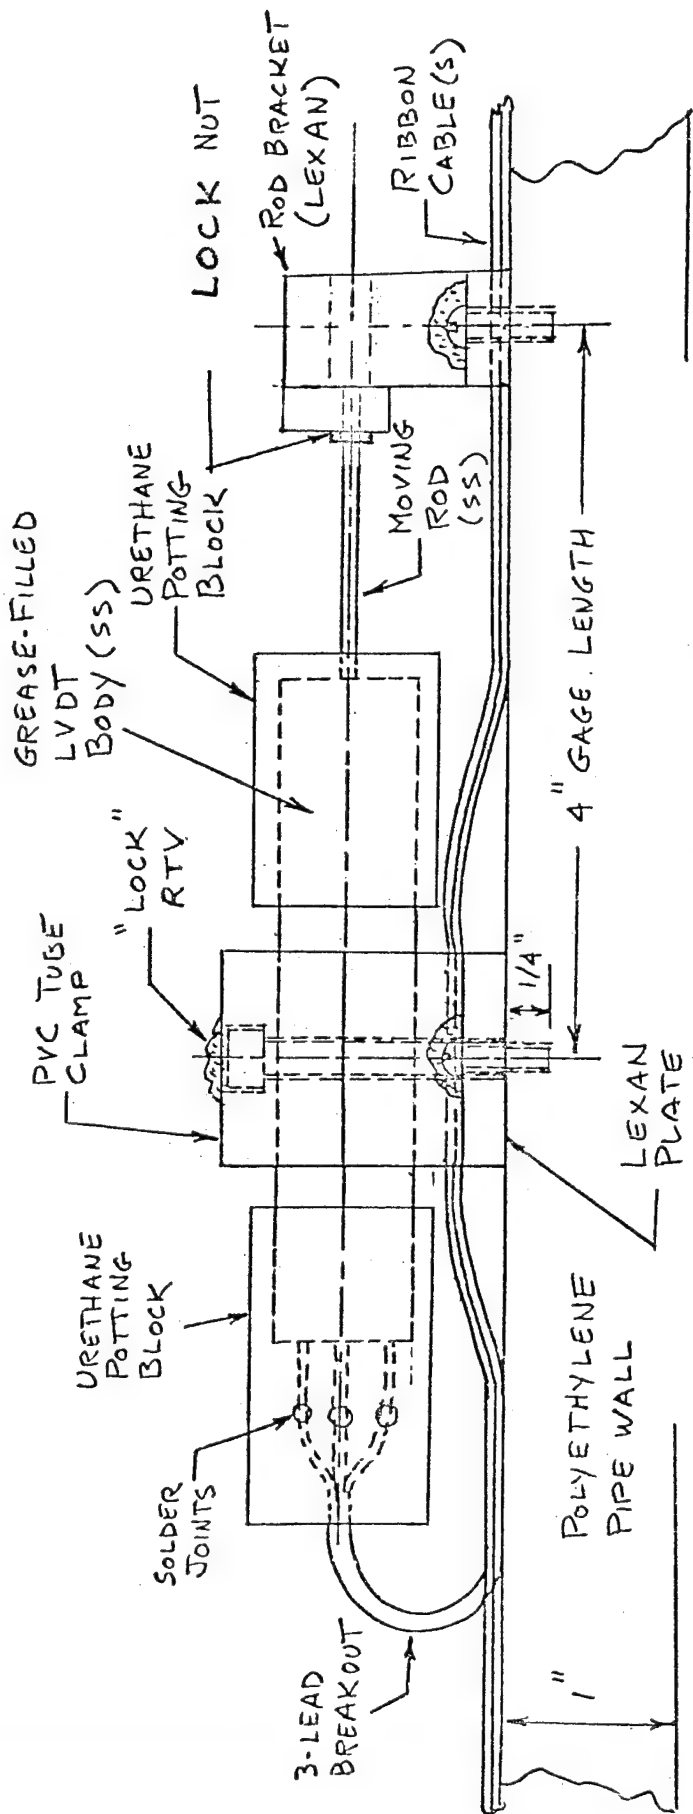
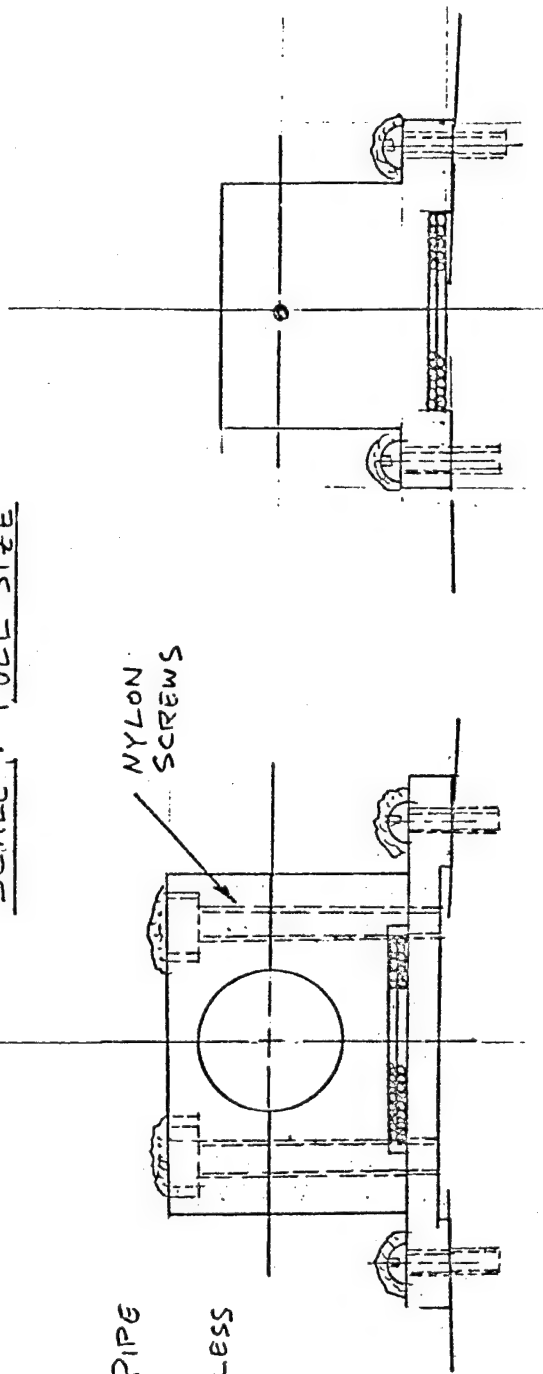
FIGURE 2- TYPICAL LVDT INSTALLATION

Figure 2 illustrates the installation details of the LVDT sensor unit. To accomplish the installation, a drill jig was used to provide alignment and location of the four mounting screws. The LVDT body was mounted first. Then the core was screwed into its mounting bracket and the assembly was slid into position and fastened to the pipe. Both LVDT body and core mounting brackets were attached with self tapping screws in blind holes.

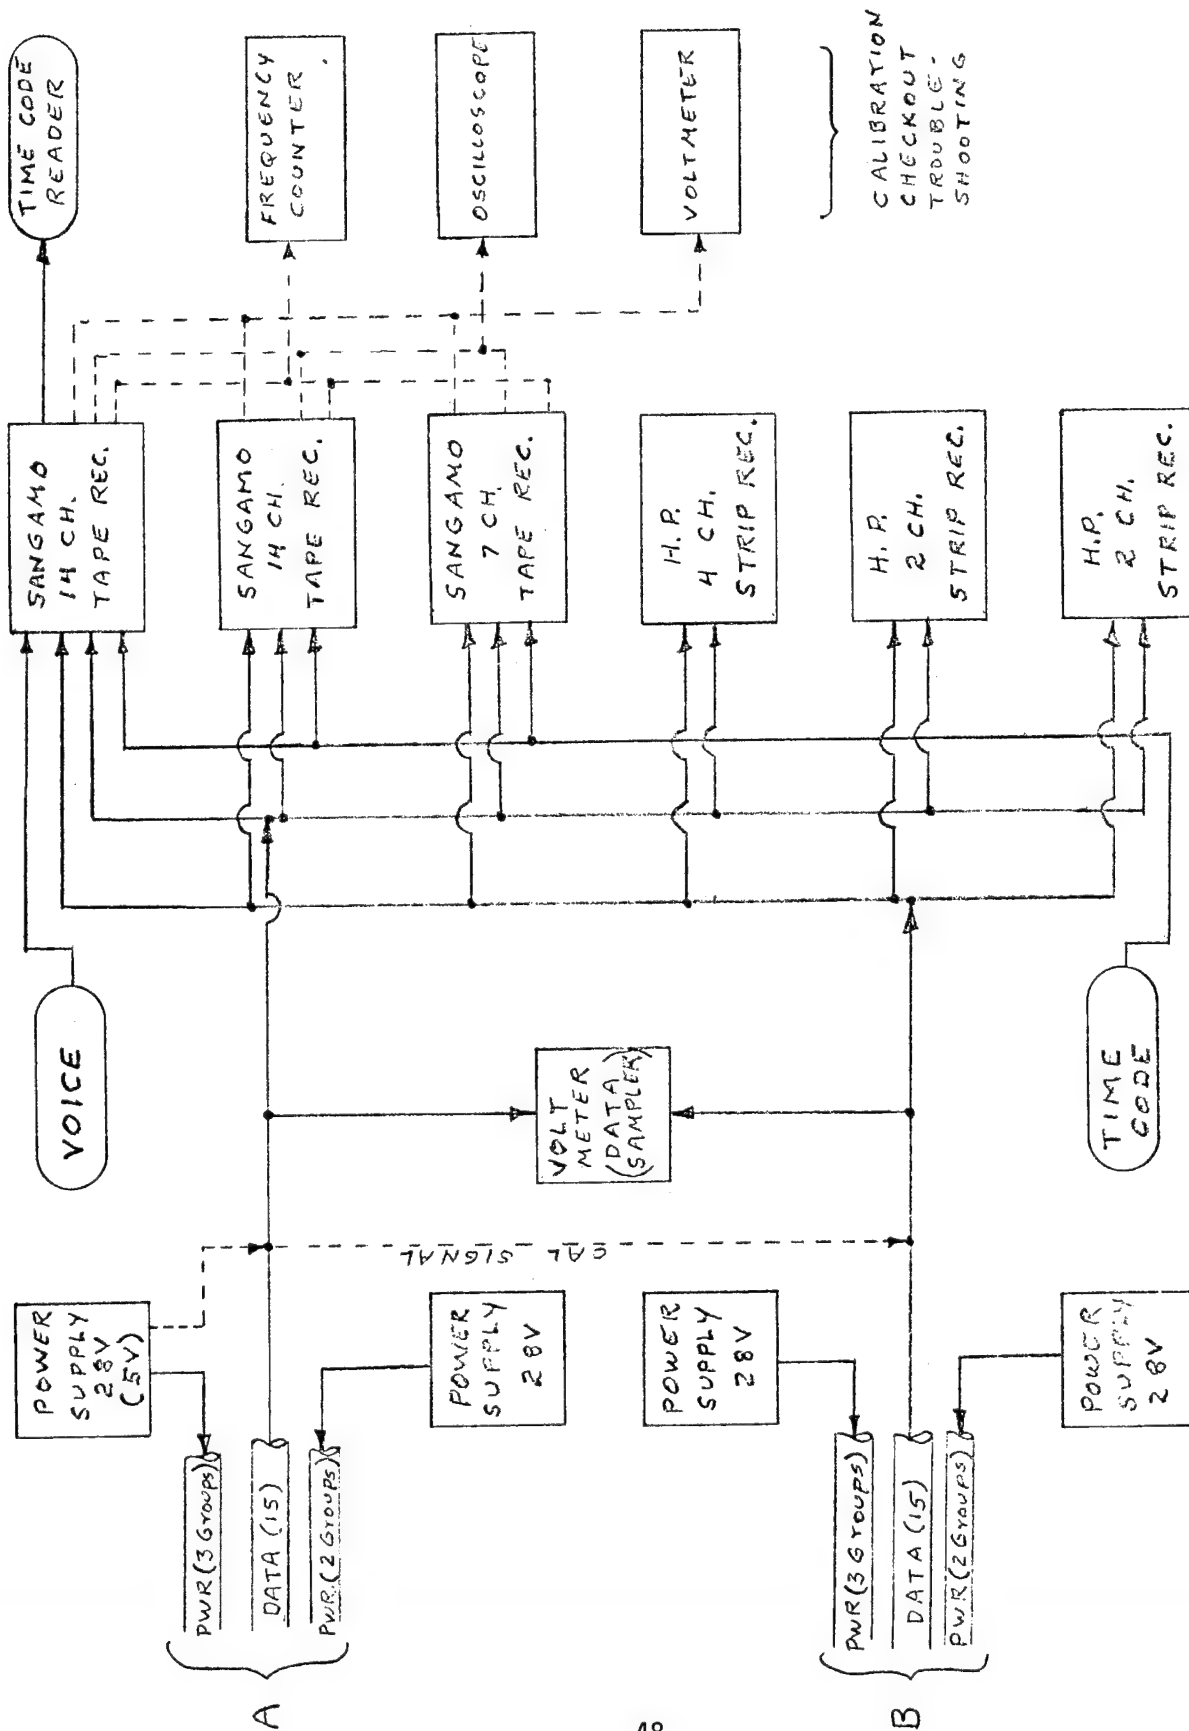
FIGURE 3 - SHIPBOARD DATA SYSTEM

A block diagram of the data recording system installed aboard the "Trojan" is shown in Figure 3. Recorders 1, 2, and 3 were 14 channel tape recorders. Recorder 3, as used, had only seven channel capability in the main frame. The other seven channels were available through an additional chassis which was not used in this operation. Voice annotation was recorded on Recorder 1 edge track, and time code was recorded on one data channel of each recorder. IRIG B time code was used. This provided a thirty-two data channel tape recording system. The three chart recorders provided eight additional channels of hard copy data for real-time viewing and evaluation.

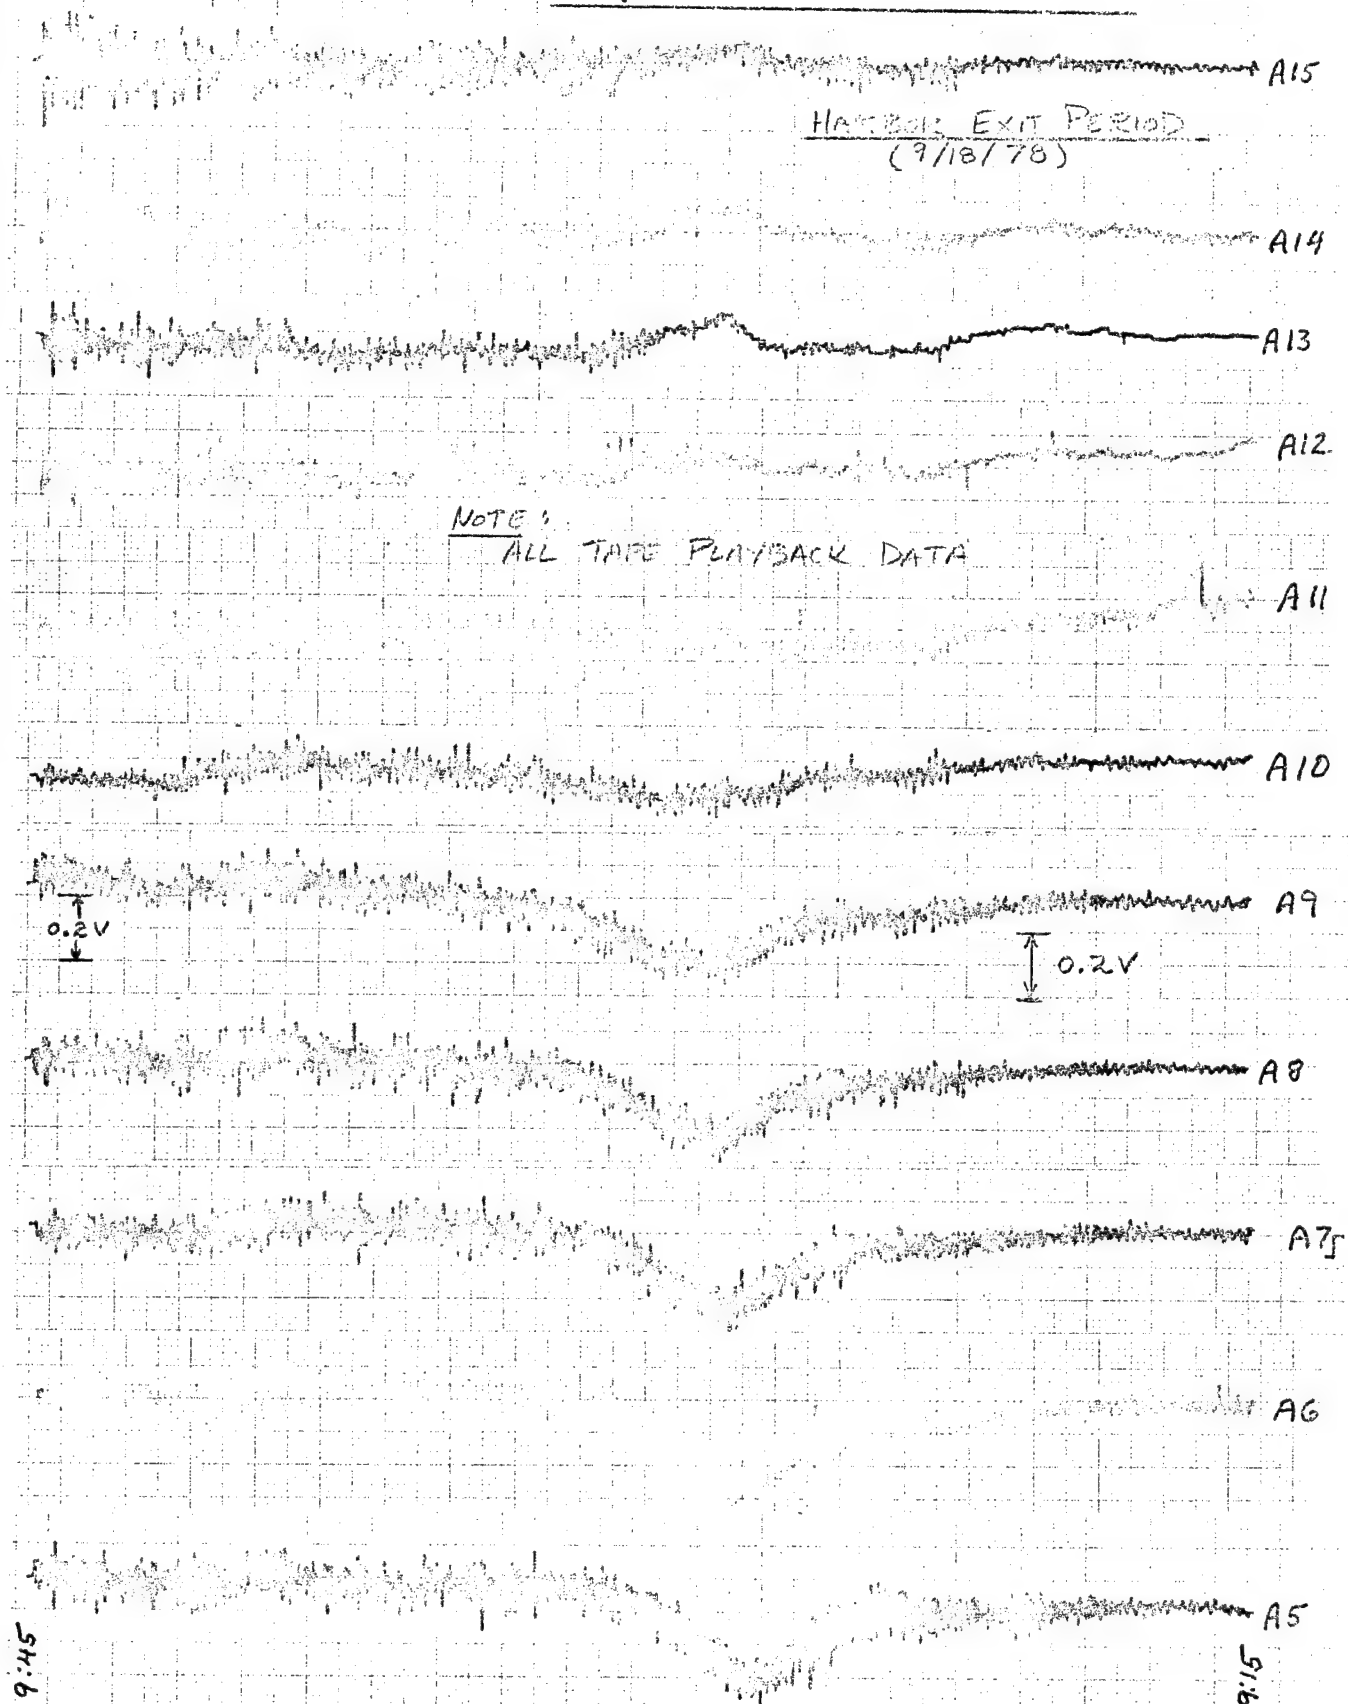
Figure 4 - LVDT OUTPUTS

The data illustrated in Figure 4 were taken from tape 1-1 for the time period the pipe was rounding the sea wall. The strains due to bending the pipe while
